Duluth Entertainment  
Convention Center

# PREDESIGN REPORT

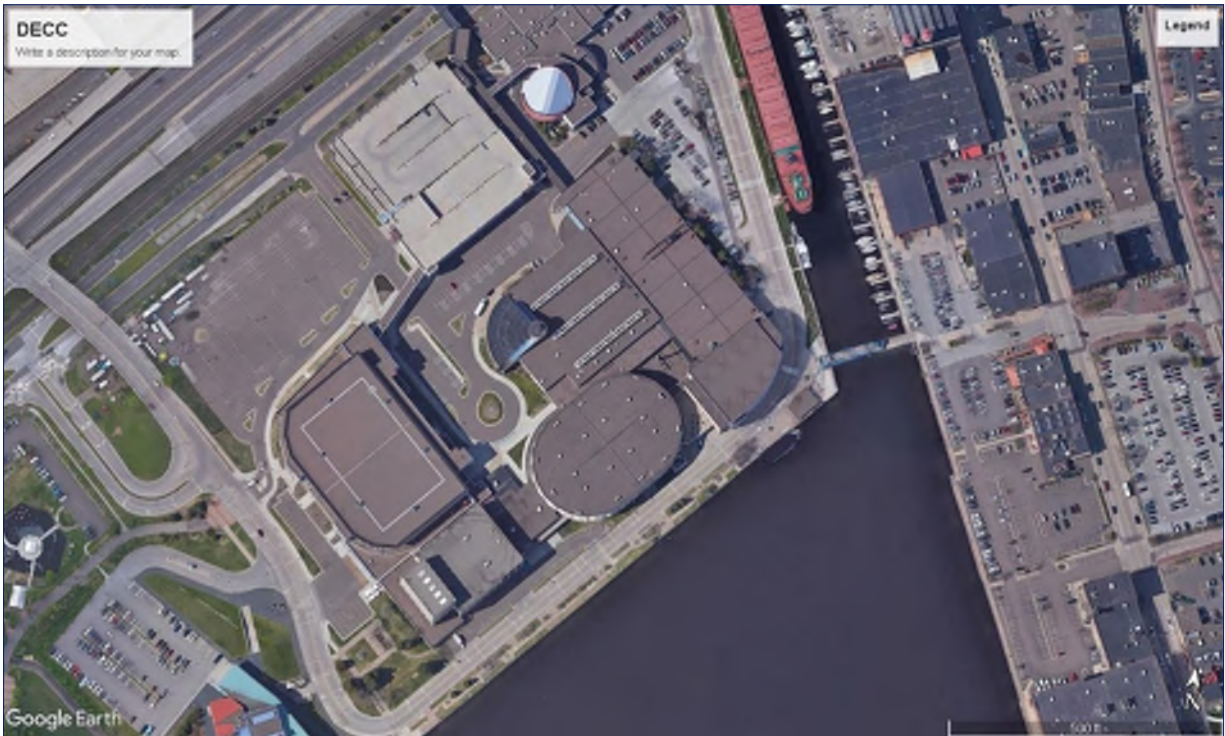
Our work was requested and authorized by Mr. Steve Rankila of Duluth Entertainment Convention Center (DECC).

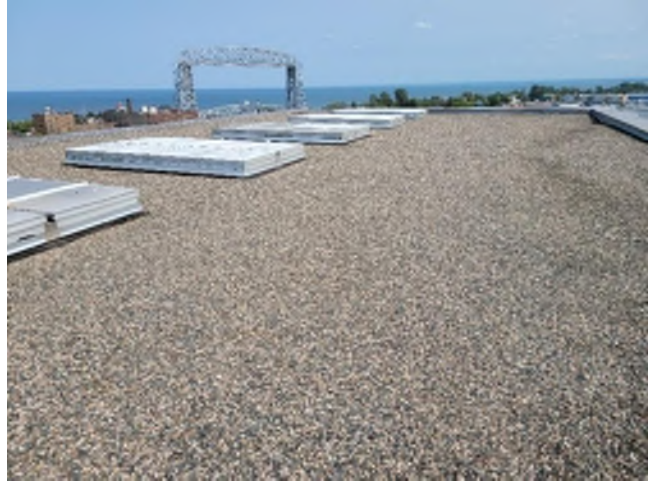
**Roof Condition:** Satisfactory

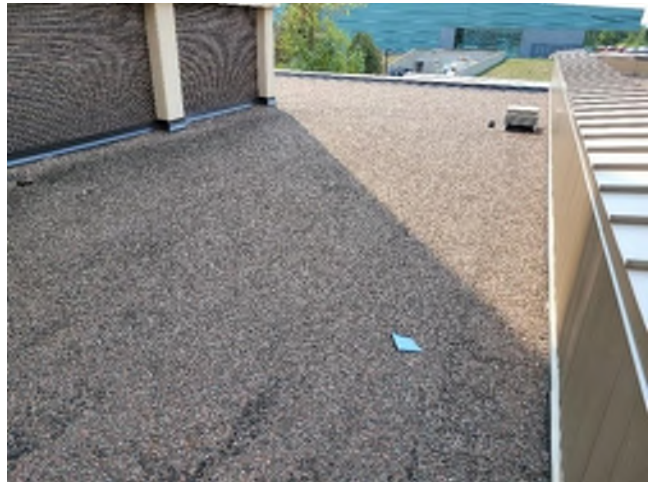
**Roof Condition:** Satisfactory

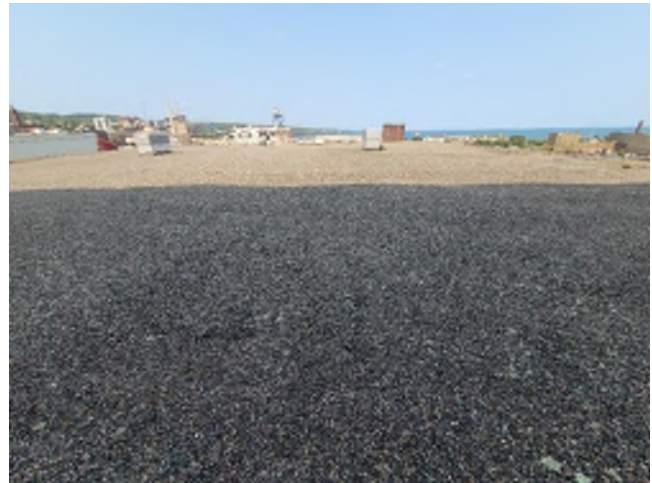
**Roof Condition:** Satisfactory

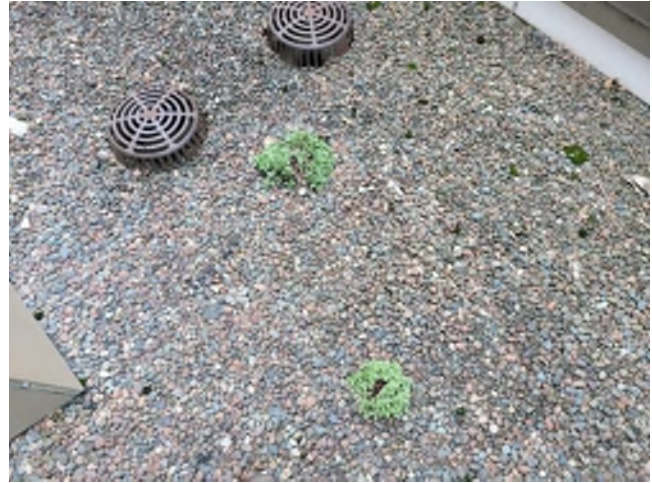
**Roof Condition:** Satisfactory

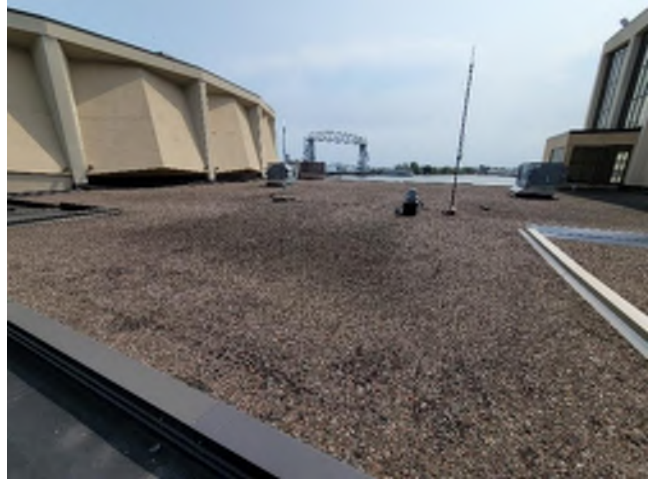
**Roof Condition:** Satisfactory

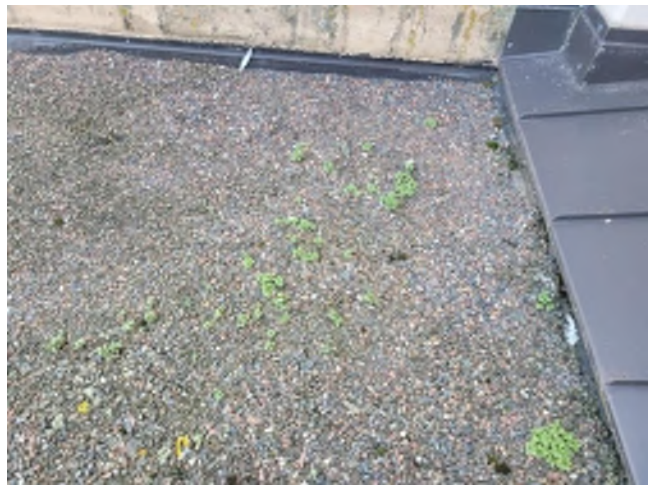
Area D – Vegetative growth is occurring in multiple locations throughout the roof area and should be removed before damage is done to the roofing by the developing root system. (Photo #10)

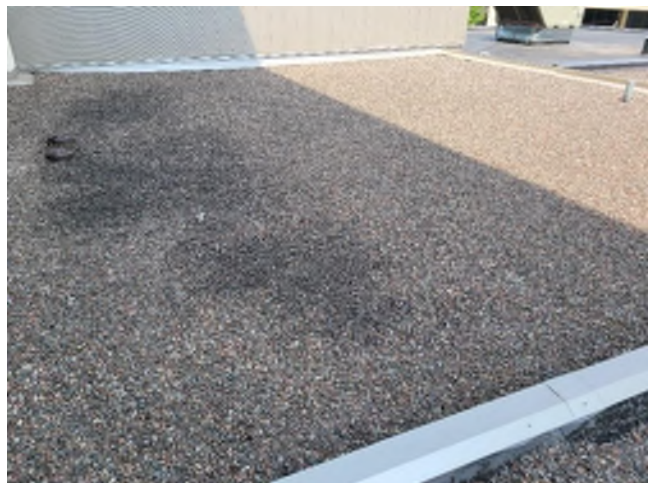
**Roof Condition:** Satisfactory

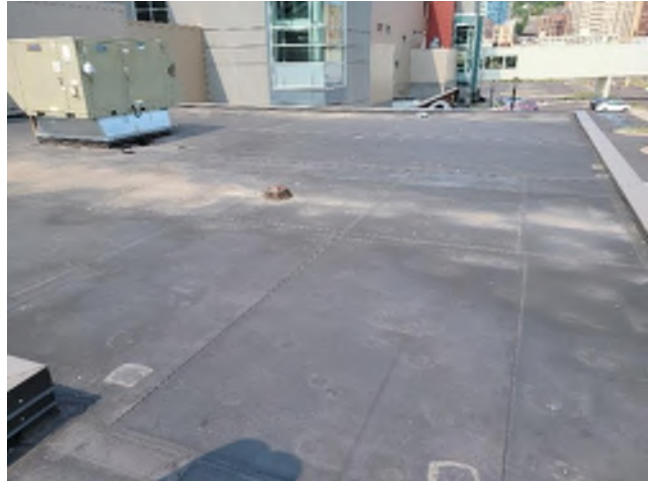
**Roof Condition:** Poor

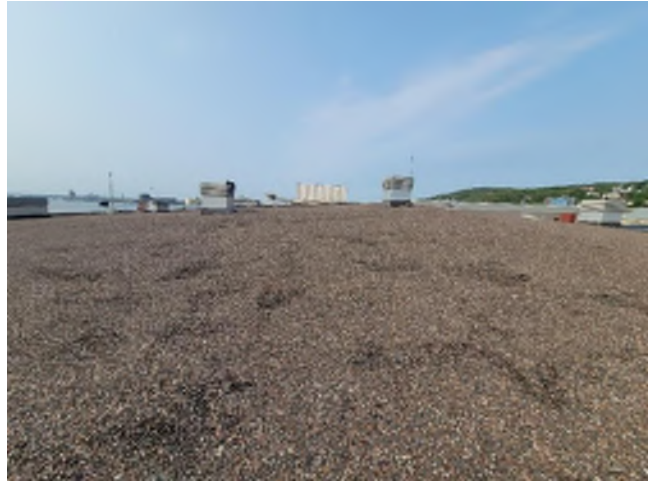
**Roof Condition:** Poor

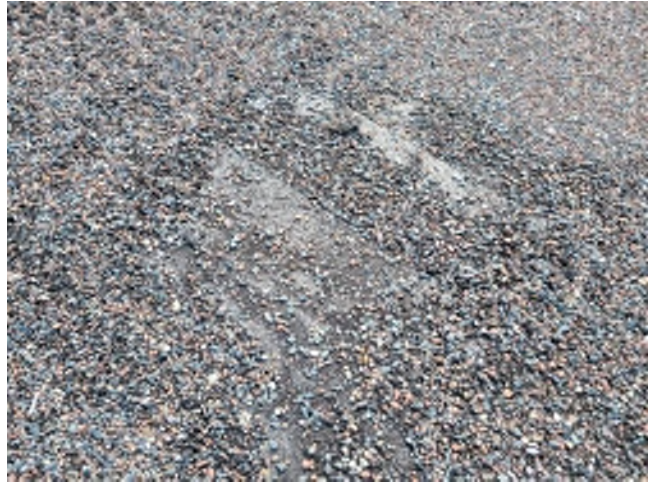
Area G – Surface erosion has occurred throughout the field of the roof membrane due to multiple factors such as extreme weather and deterioration of the roofing. The extent of the erosion has exposed the waterproofing membrane which is susceptible to UV degradation.  
(Photo #22)

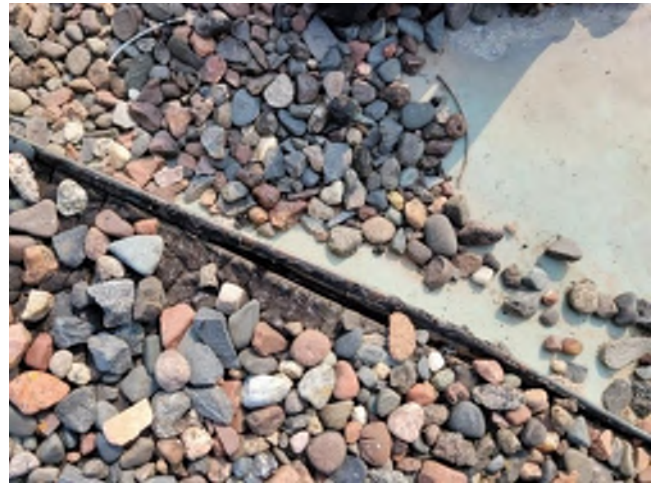
Area G – The existing interior roof drains are installed using copper drain pans; however, the pans are no longer properly sealed, allowing for moisture infiltration.  
(Photo #23)

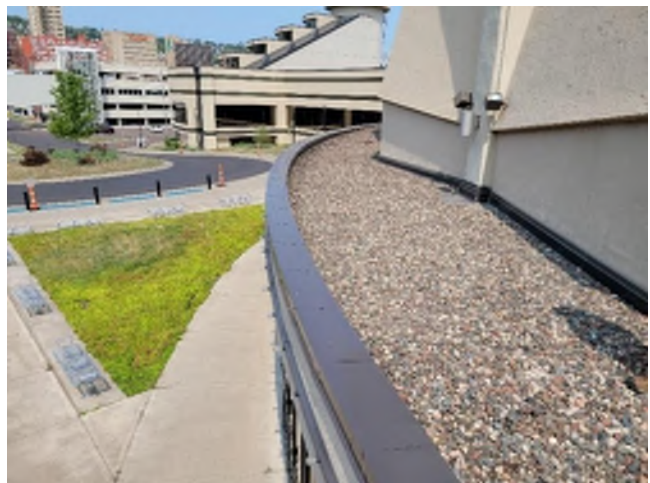
Area G1 – The roof area is composed of a ballasted EPDM roof membrane. While no leaking was reported within the roof area, leaks are known to occur within the building envelope “skin,” particularly at structural columns.  
(Photo #24)

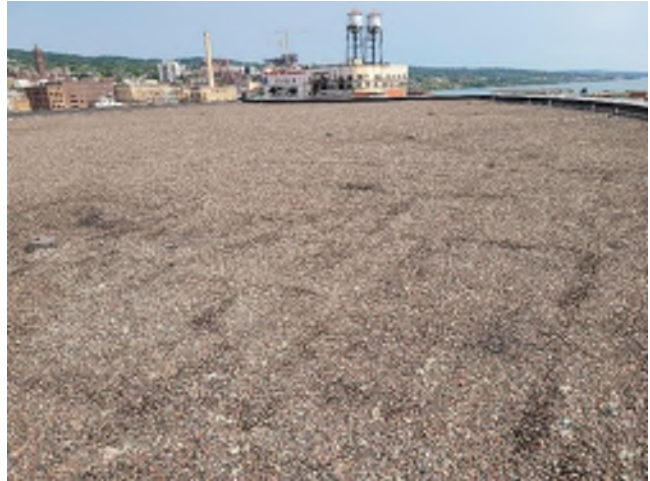
**Roof Condition:** Satisfactory

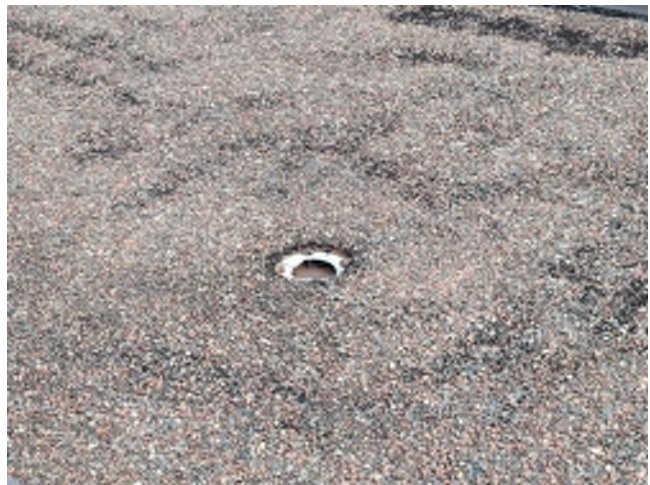
At the north end of the roof areas, one primary roof drain was missing the drain strainer which can allow debris to enter the drain leader and reduce the amount of positive drainage.  
(Photo #28)

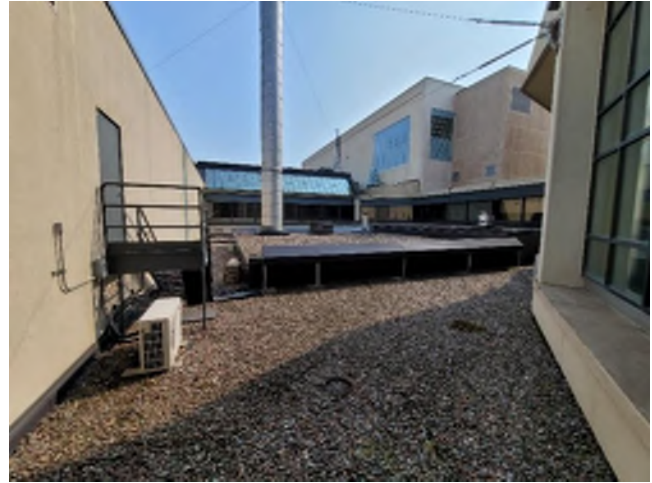
**Roof Condition:** Good

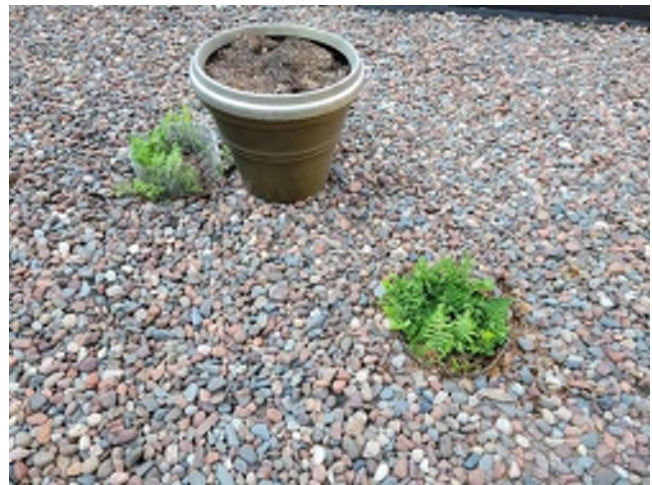
Vegetative growth is occurring at the drain locations and should be removed as soon as possible. The growth can cause premature damage to the single-ply membrane and reduce positive drainage.  
(Photo #30)

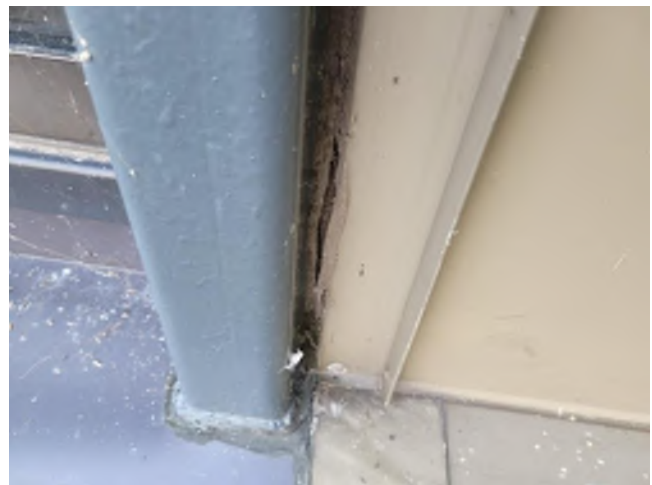
Cohesive failure of the existing sealant was observed at the wall transition between dissimilar materials, creating a location for possible moisture entry.  
(Photo #31)

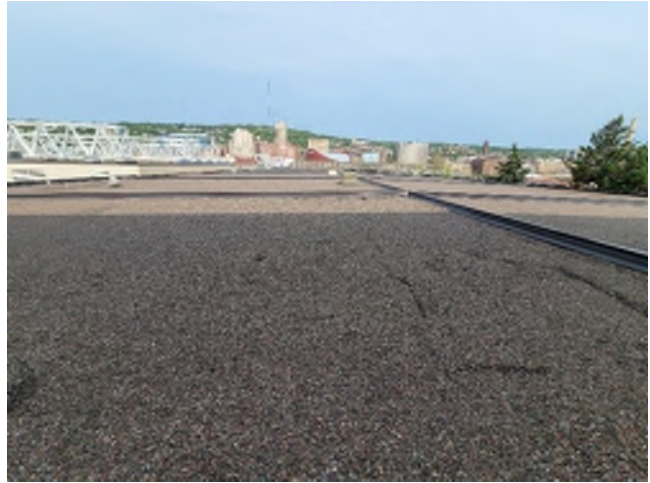
**Roof Condition:** Satisfactory

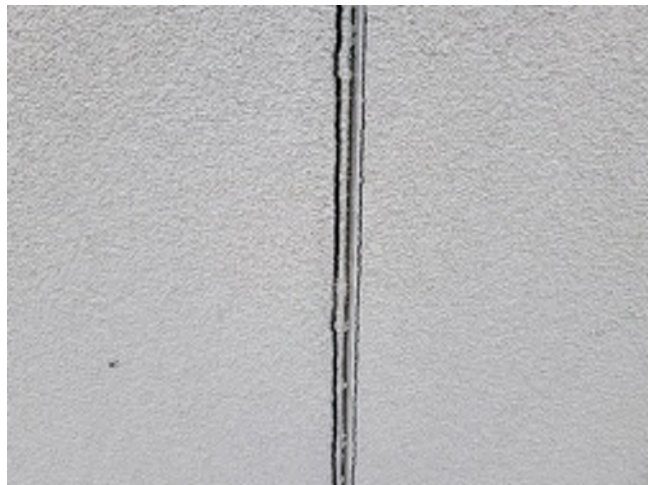
Area J – Shrinkage of the stucco panels, likely caused by not allowing proper curing between coats, is causing vertical cracking along the control joints. (Photo #33)

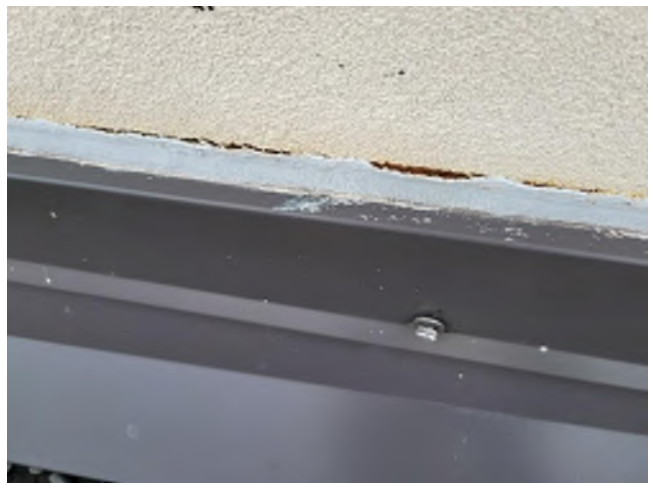
Additionally, some of the sheet metal fasteners have begun to back out due to thermal movement. (Photo #34)

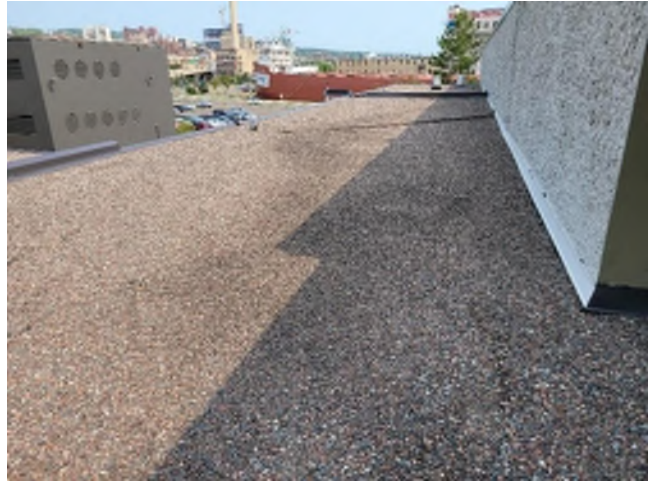
**Roof Condition:** Satisfactory

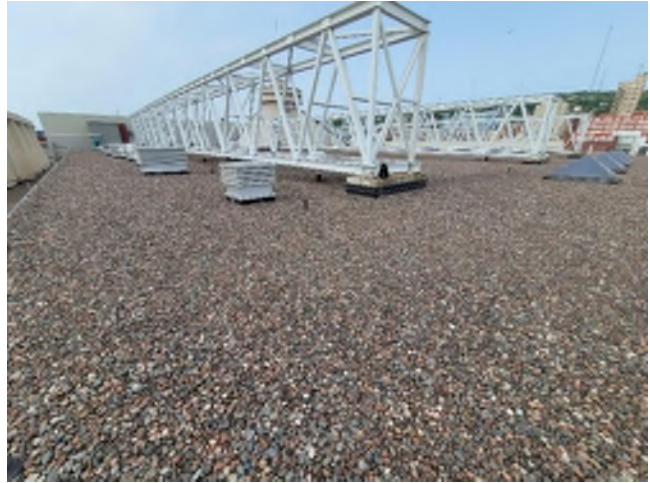
**Roof Condition:** Satisfactory

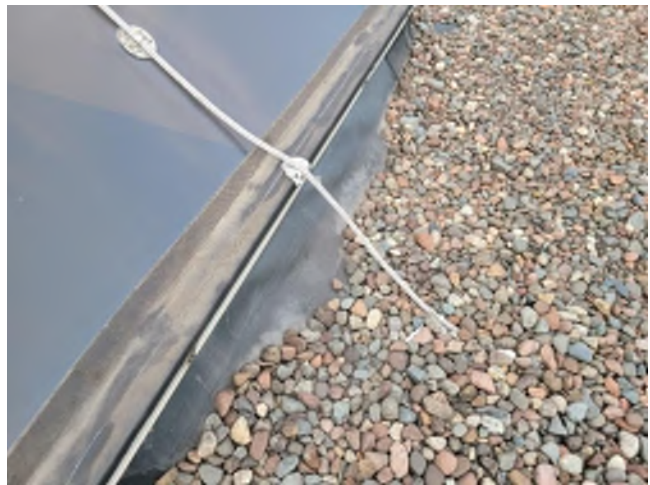
Area K – At a few locations, the existing EPDM base flashings have lost adhesion to the edge substrate causing the membrane to bridge and create an air void beneath the membrane.  
(Photo #49)

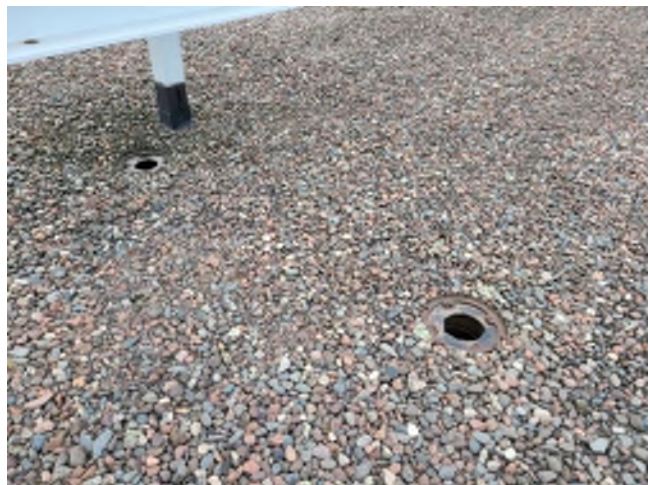
Area K – A couple of the interior roof drains are missing their corresponding strainers, allowing for debris to enter the drainage system.  
(Photo #50)

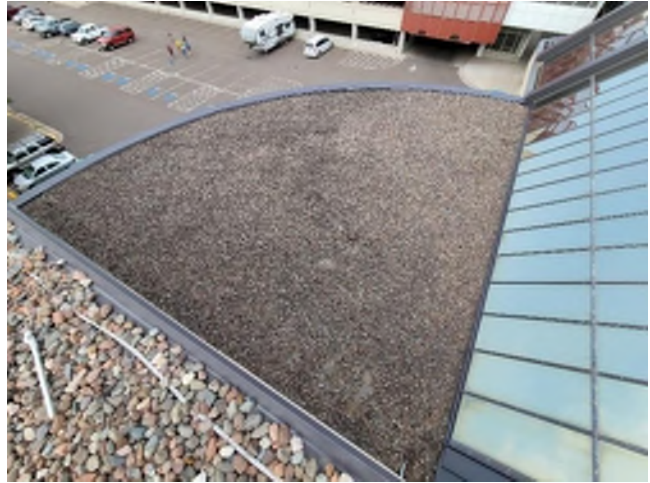
**Roof Condition:** Satisfactory

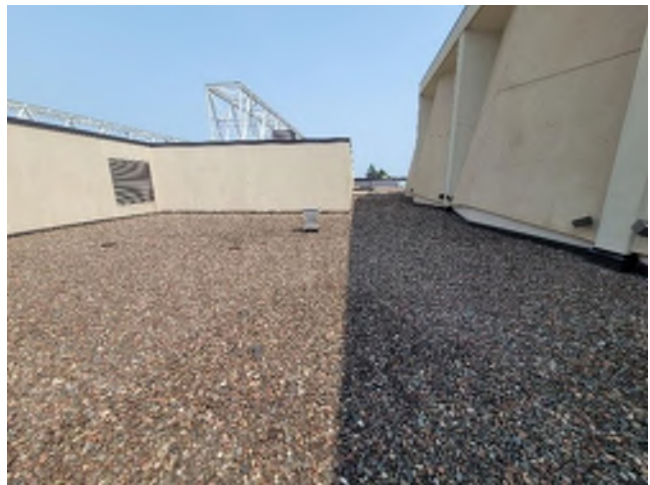
**Roof Condition:** Satisfactory

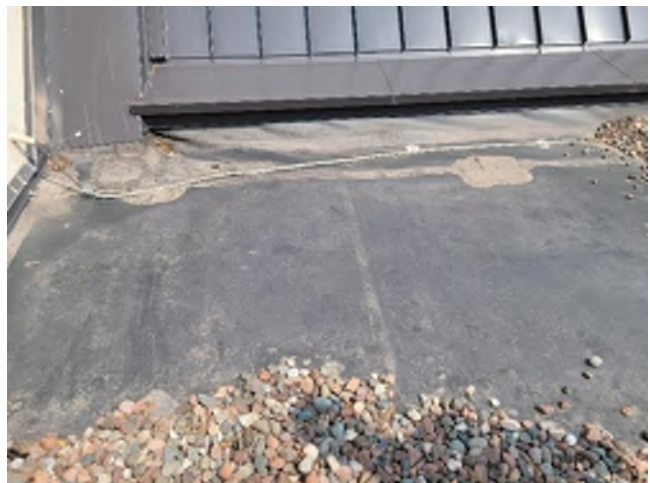
Area L – Along the northern end of the roof area, multiple deficiencies were observed including bridging flashing and ridging roof insulation. The bridging is caused by the membrane shrinking and losing adhesion to the wall substrate while the ridging of the insulation is likely caused by moisture trapped within the insulation boards. (Photo #53)

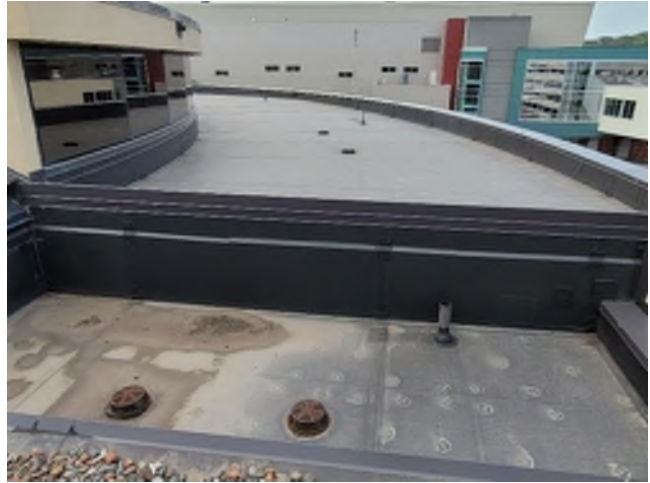
**Roof Condition:** Good

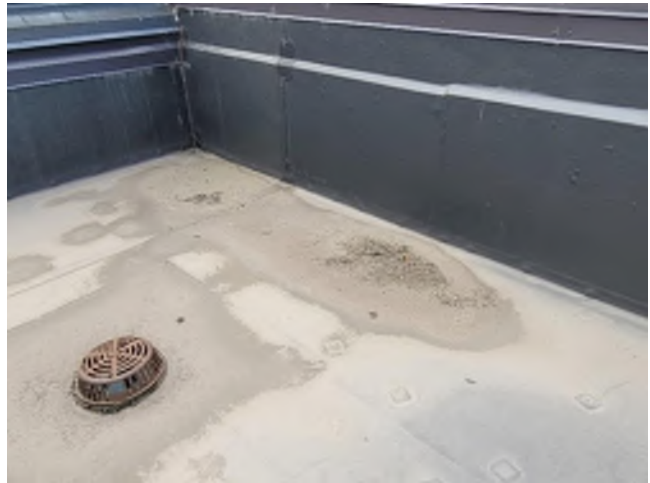
**Roof Condition:** Good

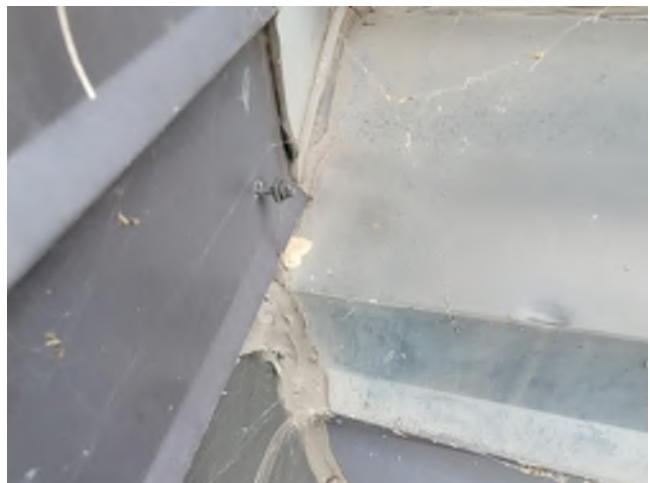
**Roof Condition:** Good

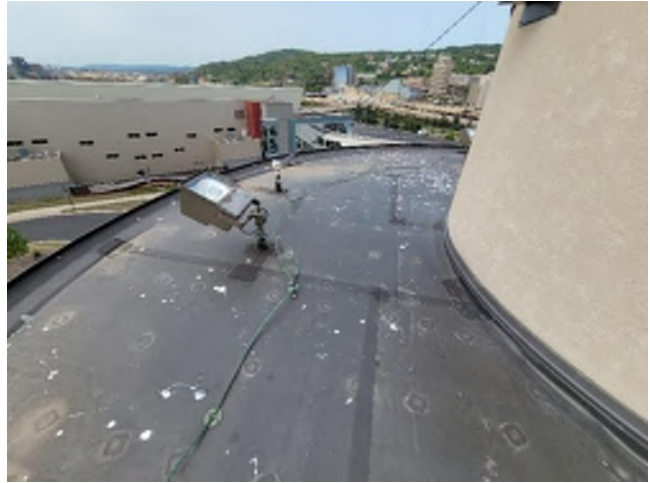
**Roof Condition:** Good

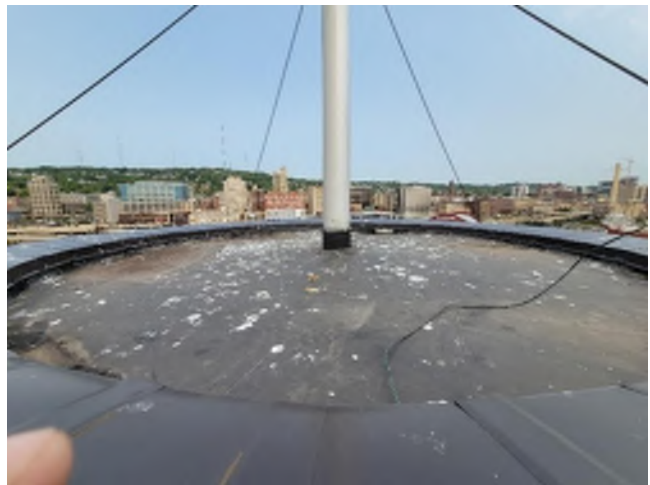
**Roof Condition:** Good

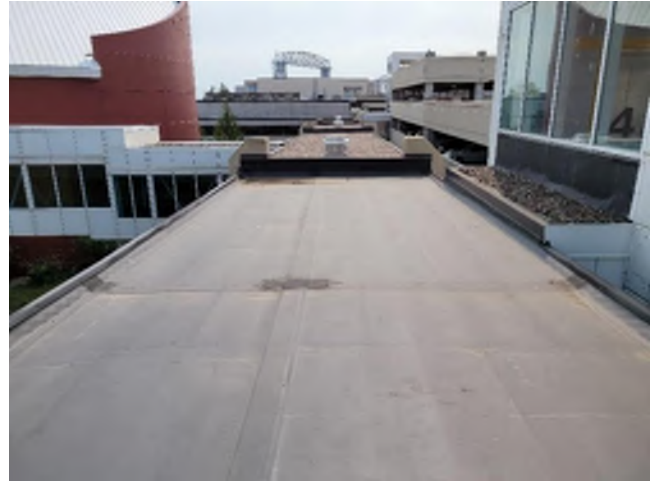
**Roof Condition:** Good

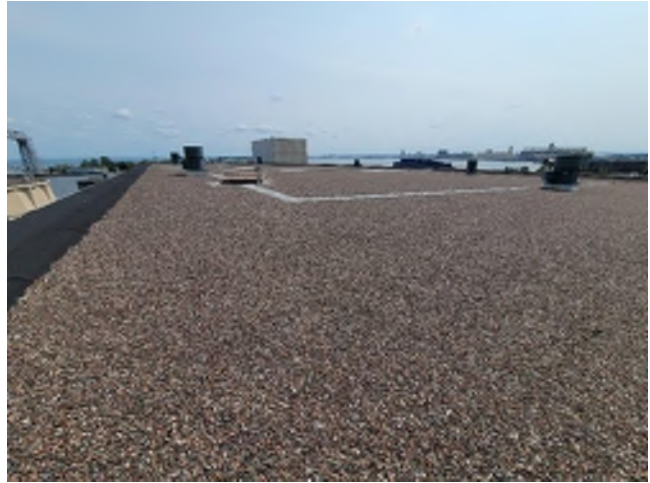
**Roof Condition:** Good

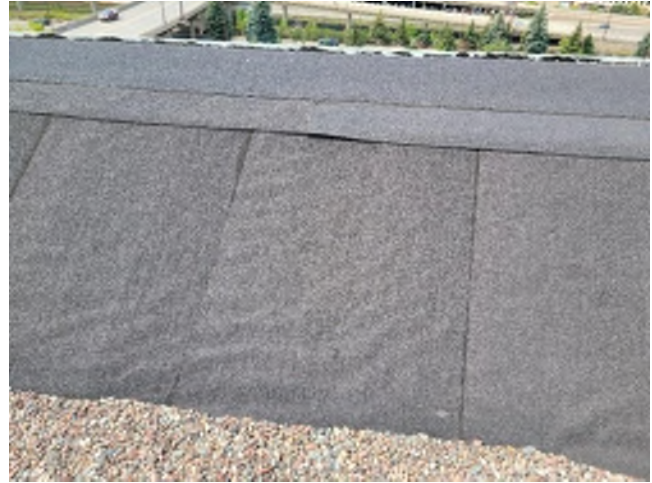
Area Q – Some of the existing base flashings are beginning to sag due to the height of the wall and the continual softening of the cap sheet membrane. (Photo #64)

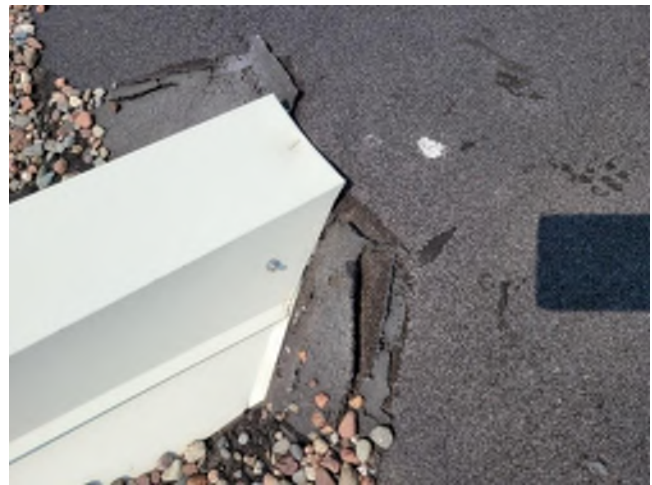
Area Q – The originally installed roofing cement is displaying signs of UV degradation. It is recommended that new roof cement and reinforcing fabric be applied at the same location. (Photo #65)

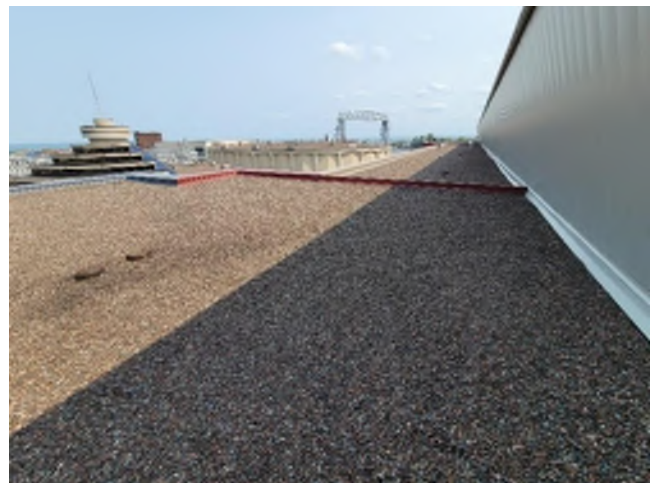
Areas Q1 – Q3: The roof areas are composed of a built-up roof membrane that was installed around 2011. Overall, the roof assembly appeared to be in good condition with no issues observed. (Photo #66)

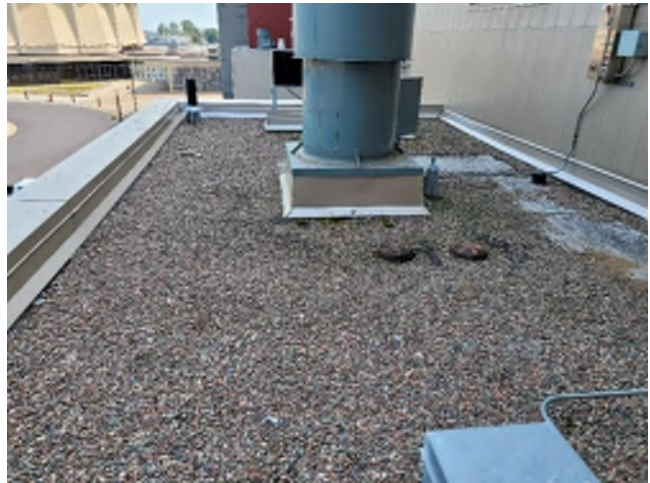
**Roof Condition:** Good

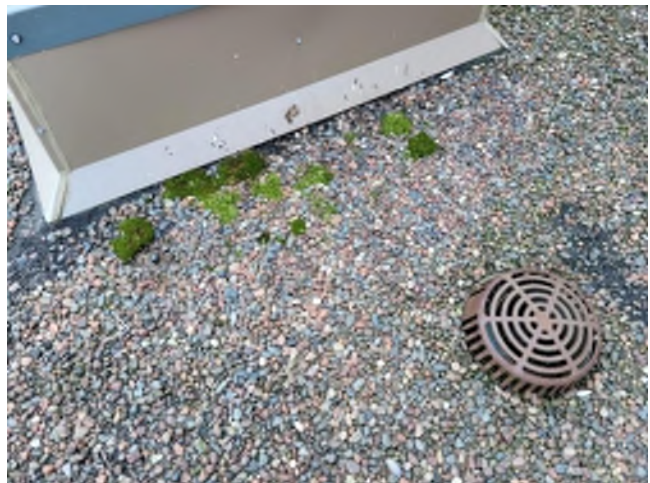
Area Q4 – Some minor vegetative growth was found and should be removed as soon as possible. The vegetative root system as it grows and develops can cause additional damage to the roof membrane.  
(Photo #68)

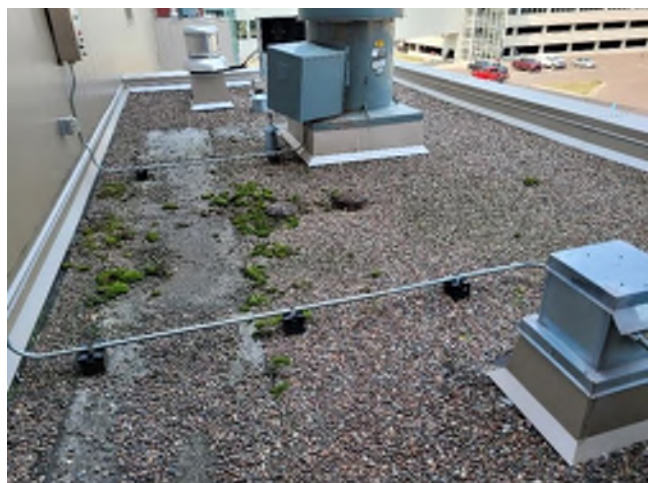
**Roof Condition:** Good

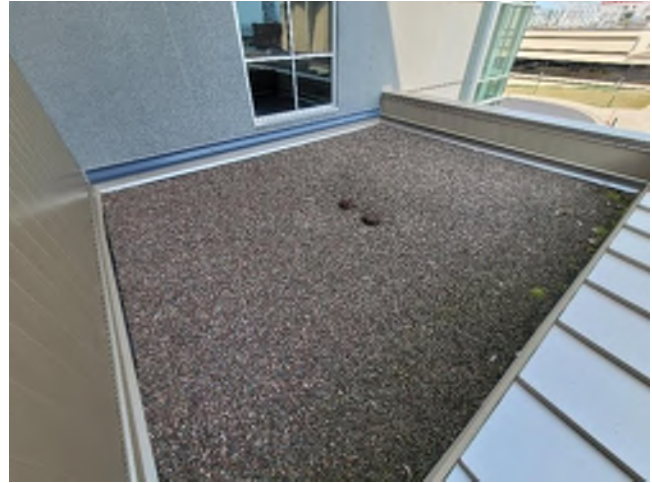
**Roof Condition:** Good

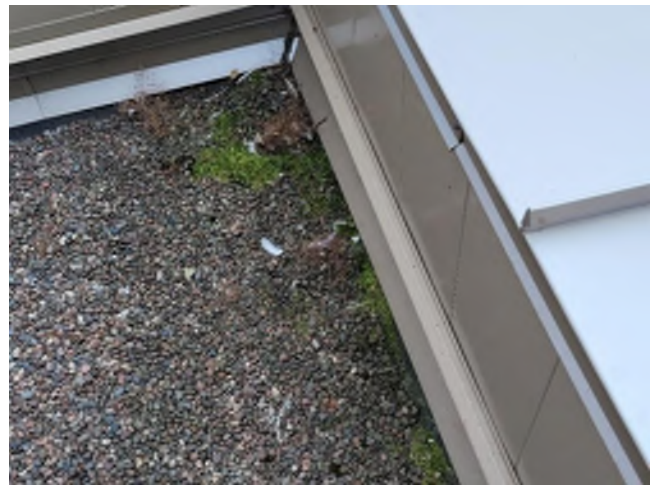
Area Q6 – Some minor vegetative growth was present and should be removed. As the root system develops, it can cause damage to the BUR membrane.  
(Photo #71)

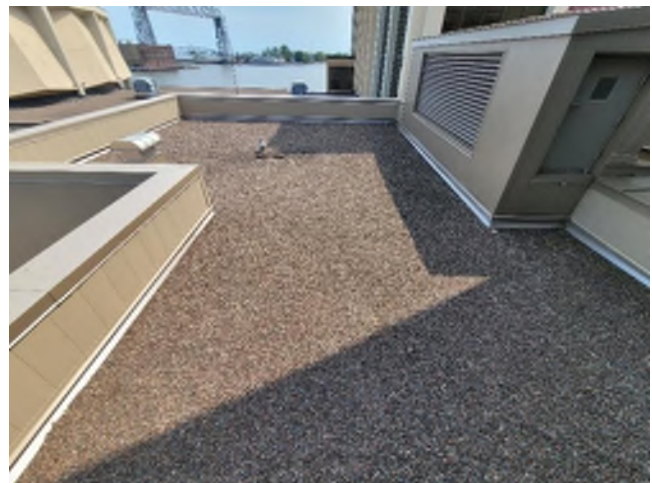
**Roof Condition:** Good

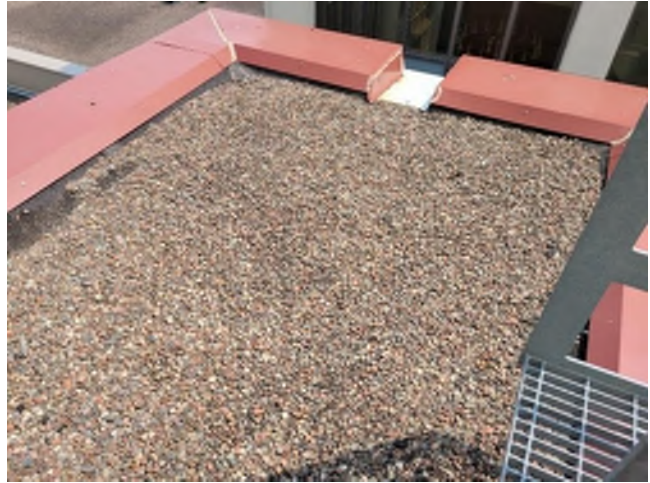
**Roof Condition:** Good

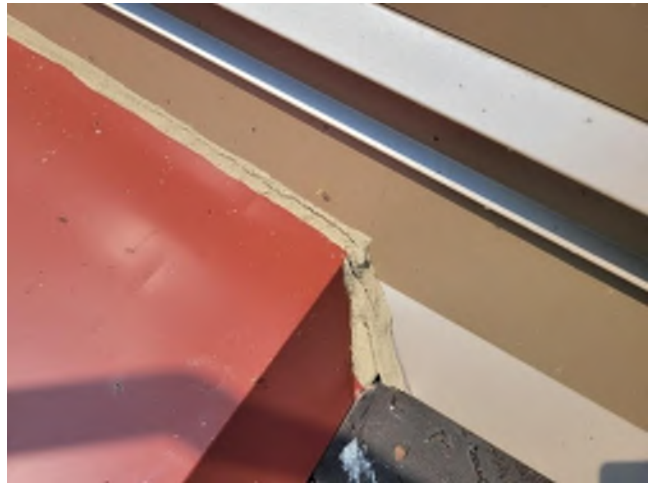
Area Q9 – At the roof-to-wall transition, the existing sealant is displaying signs of cohesive failure as the sealant is breaking down within the bulk layer of the adhesive and creating a location for moisture entry. (Photo #74)

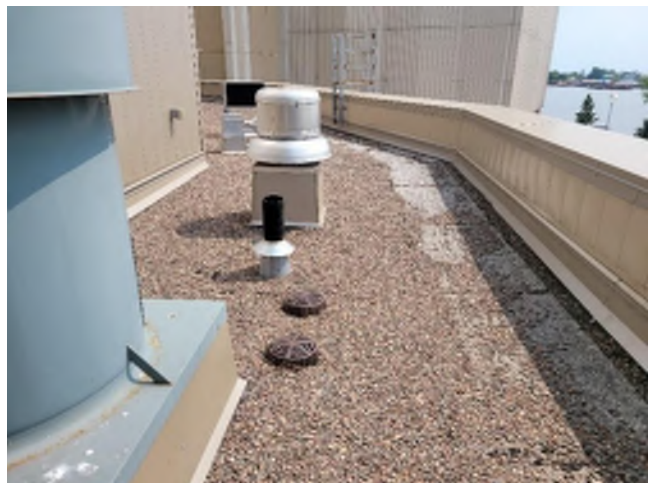
**Roof Condition:** Good

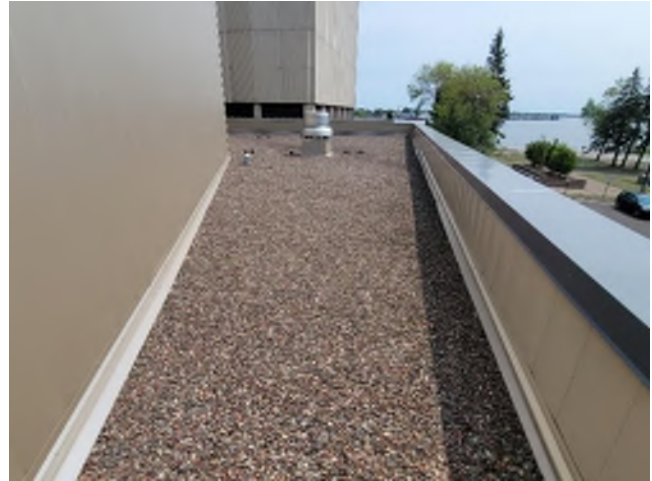
**Roof Condition:** Good

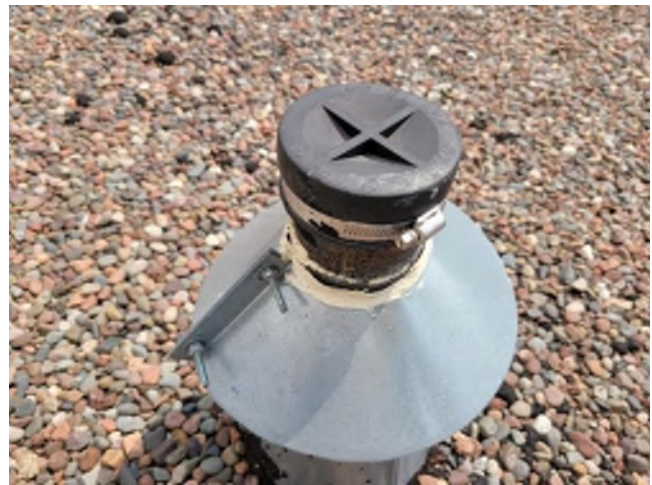
Area Q11 – At an obsolete roof stack penetration, the existing sealant at the rain collar has failed and is no longer properly adhered, allowing for moisture infiltration.  
(Photo #77)

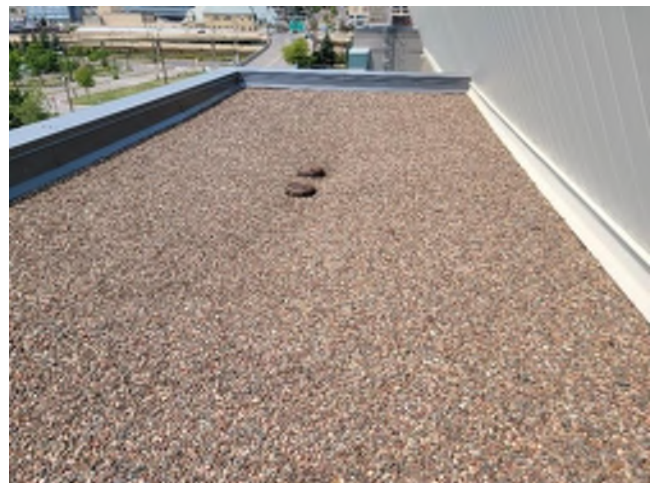
**Roof Condition:** Good

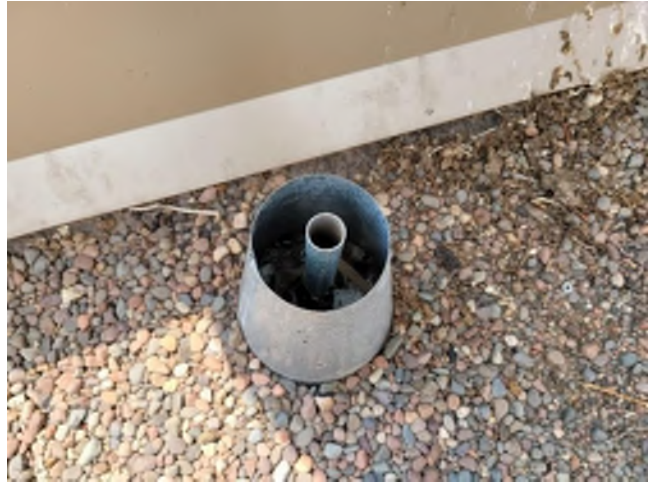
**Roof Condition:** Good

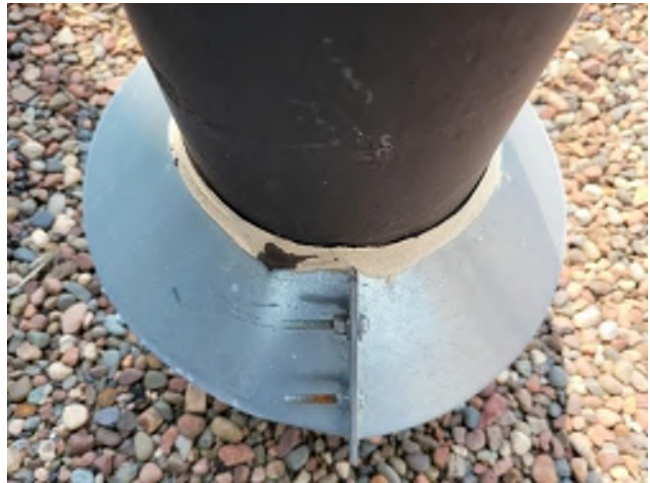
Area Q13 – Existing sealant at rain collars has lost adhesion to the roof stack substrate and should be replaced with new to prevent moisture infiltration.  
(Photo #80)

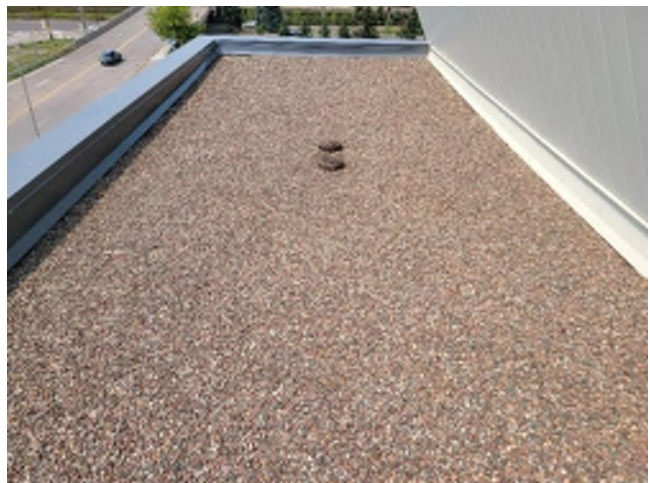
**Roof Condition:** Good

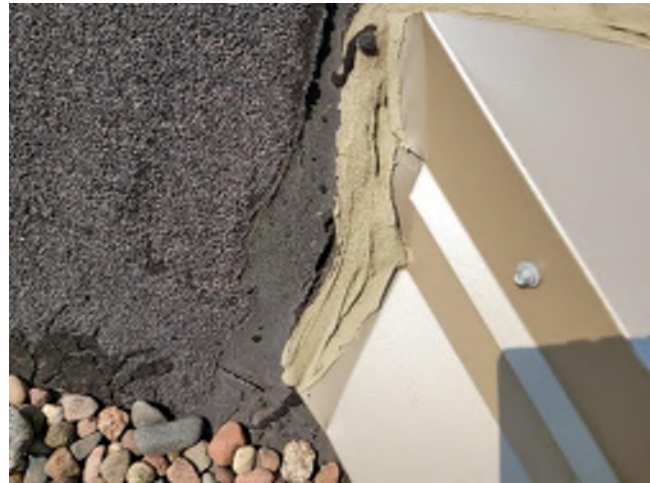
**Roof Condition:** Good

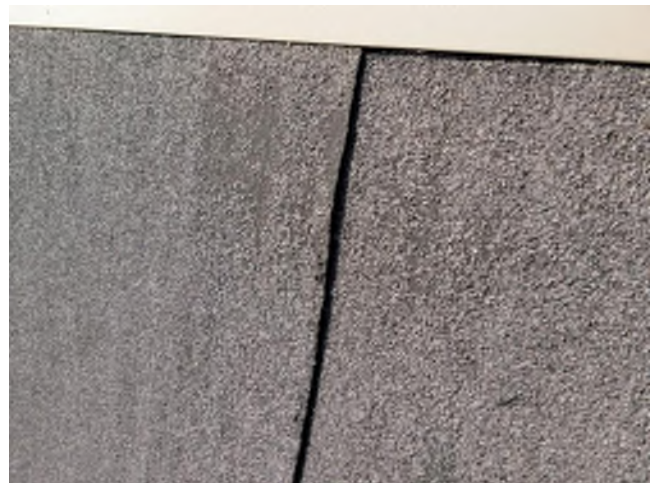
Areas Q15 & Q16 – At a few locations, the side laps of the modified bitumen base flashing have lost adhesion to the adjacent membrane sheet creating a fishmouth and a location for moisture infiltration.  
(Photo #83)

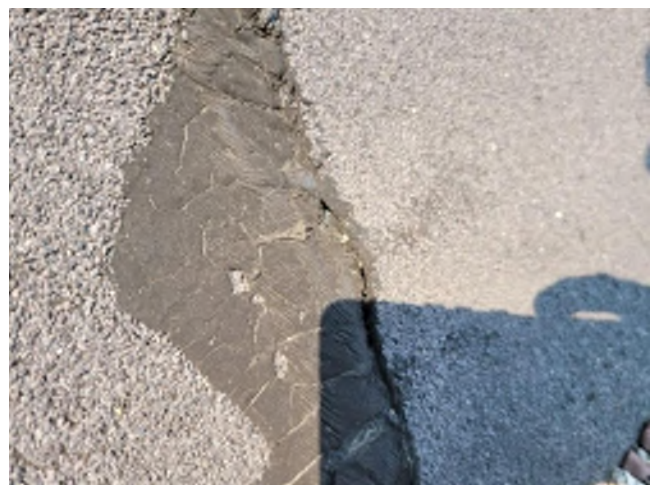
**Roof Condition:** Good

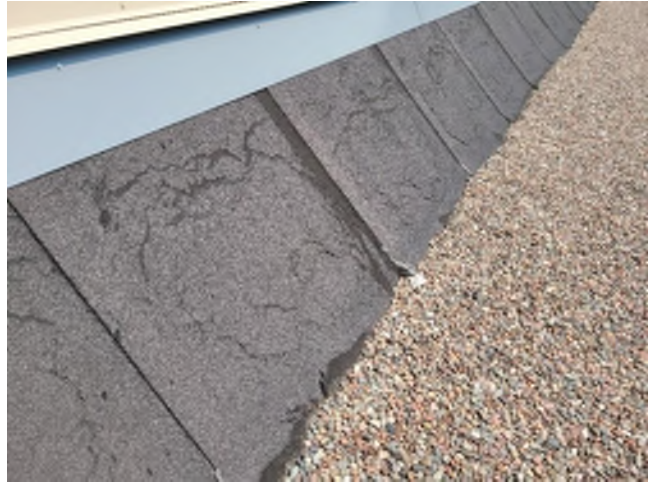
Area Q17 – The modified bitumen base flashing is displaying signs of UV degradation and is beginning to show signs of sagging.  
(Photo #85)

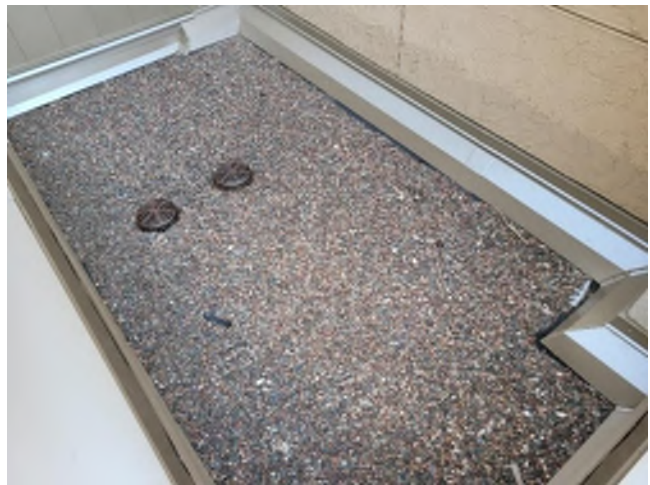
Area Q18 – Overview of the existing built-up roof membrane that was installed in 2011. The roofing appeared to be performing adequately and is in good condition.  
(Photo #86)

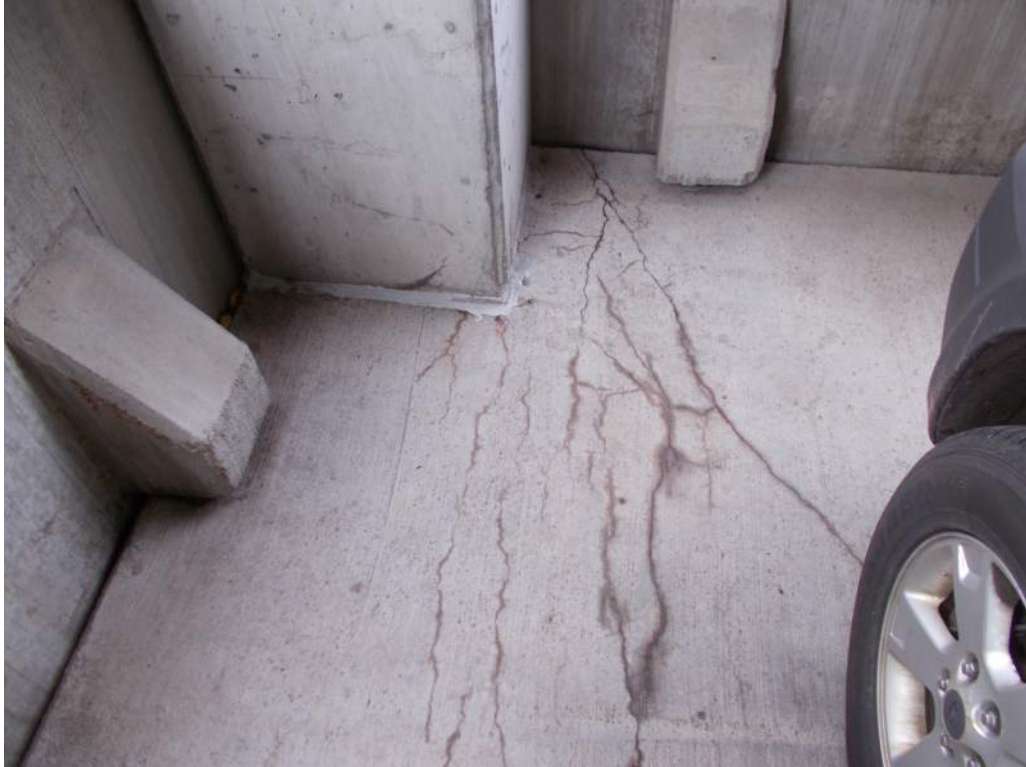
Photo 1 – Original Structure – Hairline cracking in elevated deck at column

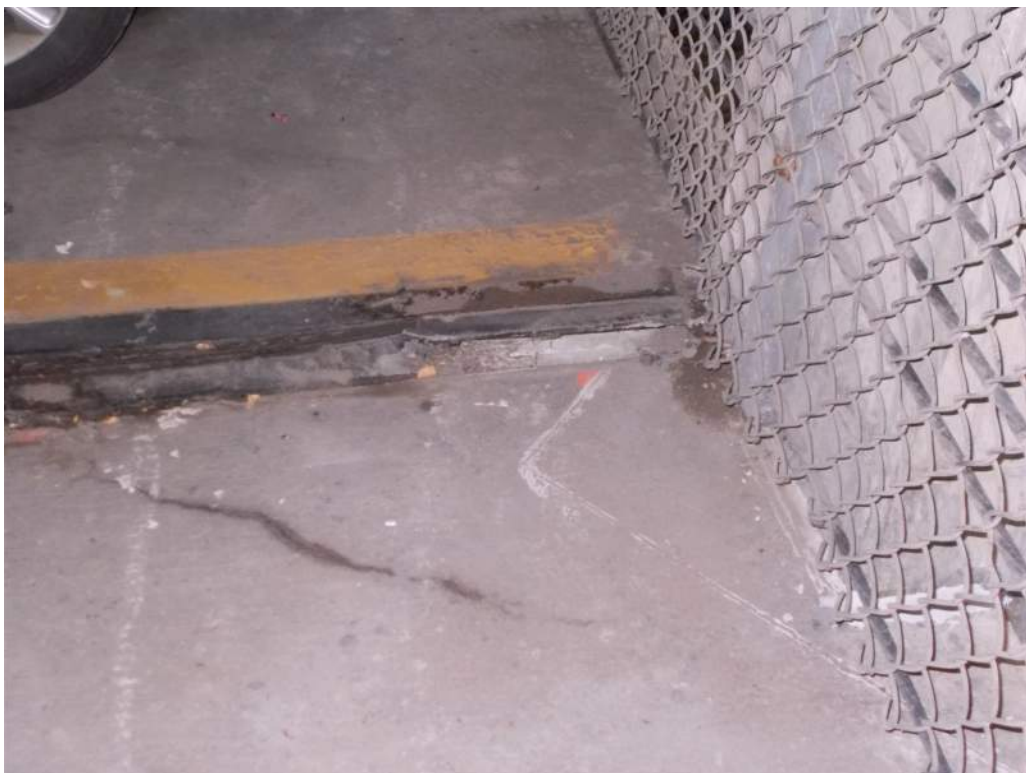
Photo 2 – Original Structure – Failed expansion joint at slab on grade to elevated slab interface

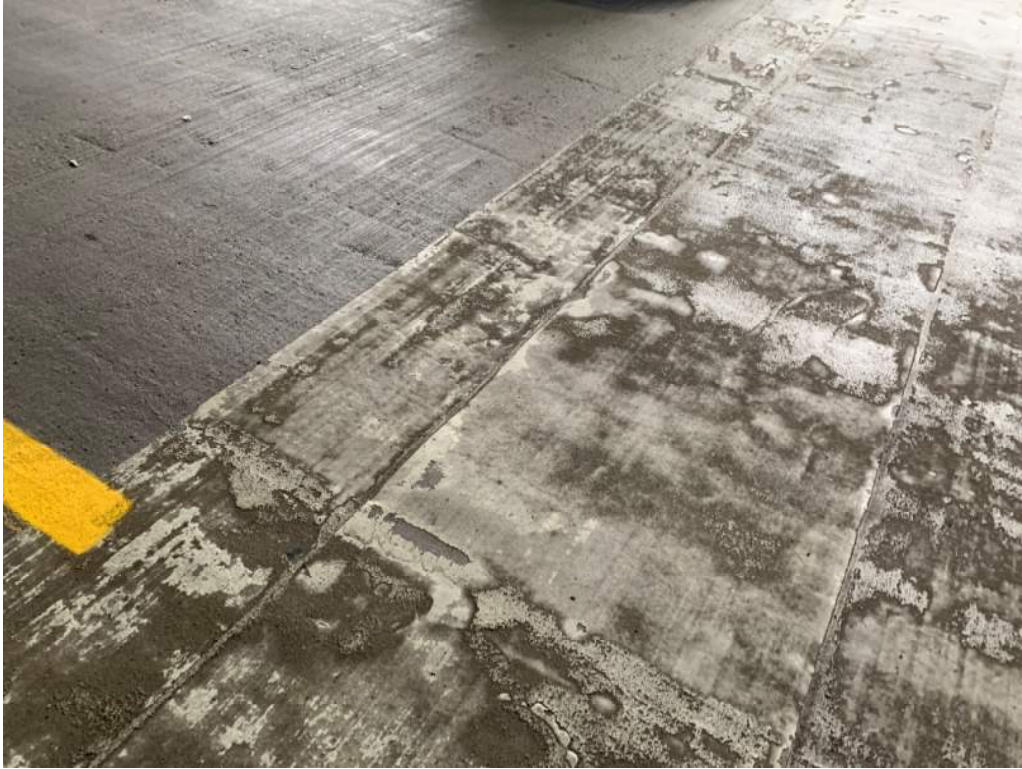
Photo 3 – Original Structure – Failed traffic coating over concrete pour strip (Level 3 shown, other levels similar)
