Duluth Entertainment  
Convention Center

# PREDESIGN REPORT

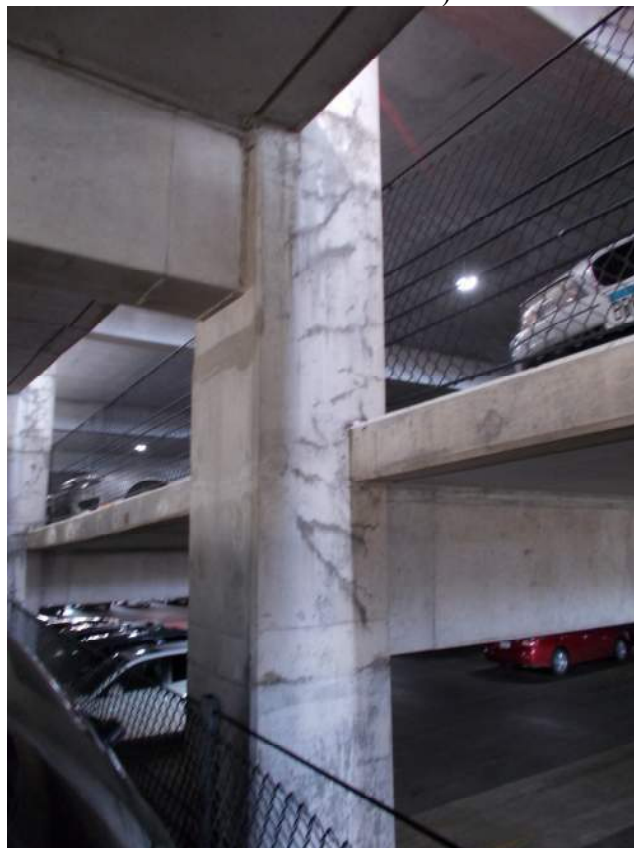
Photo 4 – Original Structure – Typical hairline column cracking at staggered beam interface

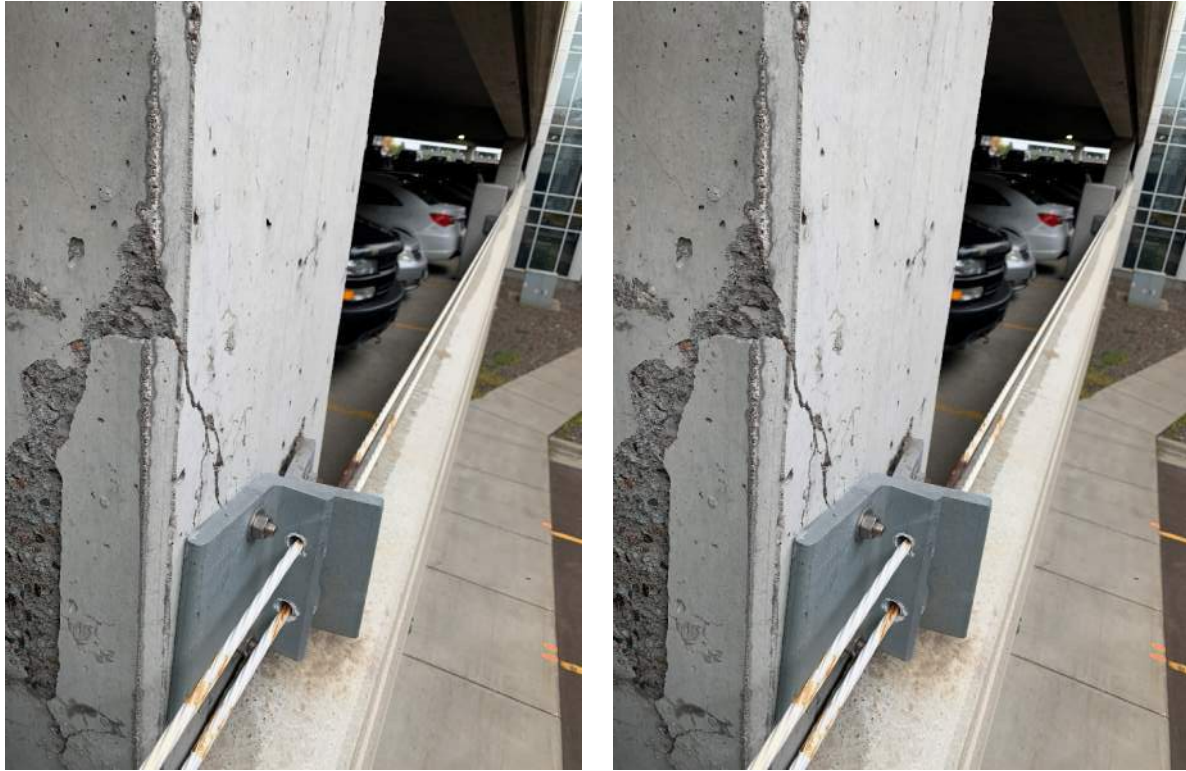
Photos 5 – Original Structure – Cracked and spalled column corner at N/5 (barrier strand anchorage) between levels 2 and 3.

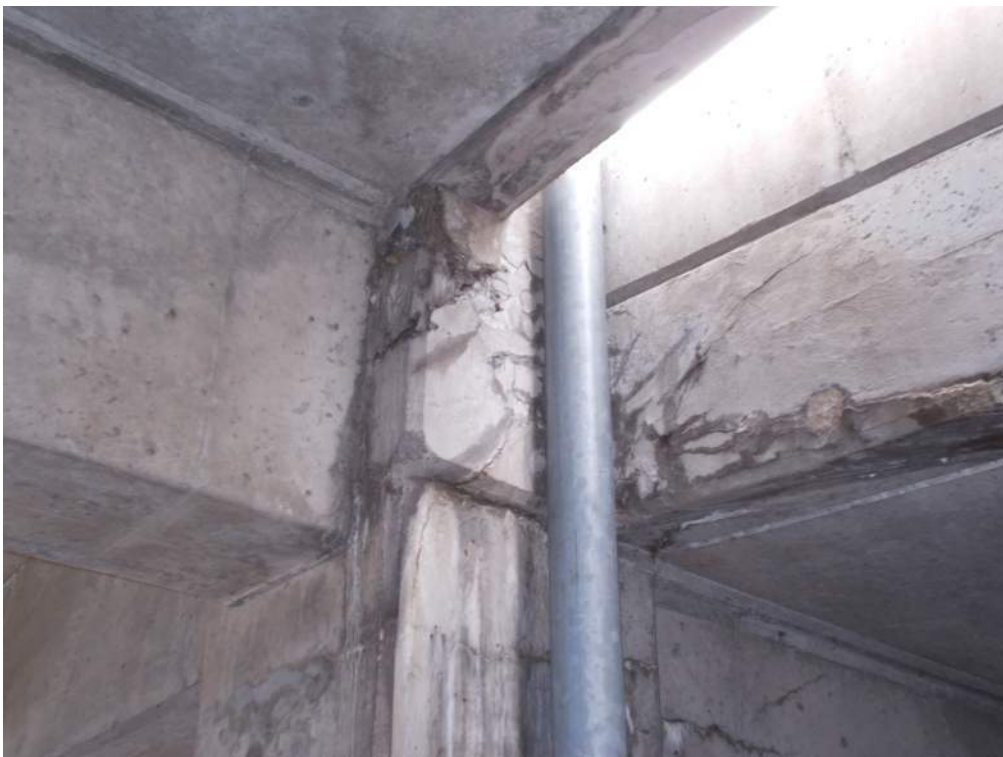
Photo 6 – Original Structure – Crack and spalled concrete in column at Grid E/4

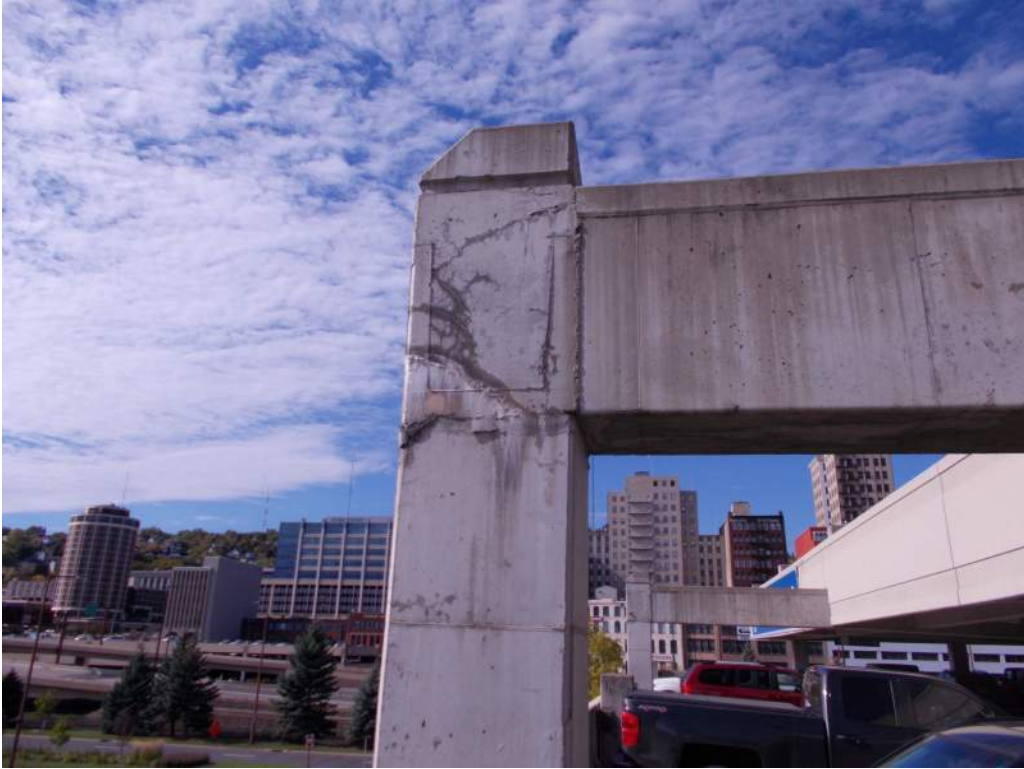
Photo 7 – Original Structure – Cracked top of column at Grid B/4 (B/3 similar)

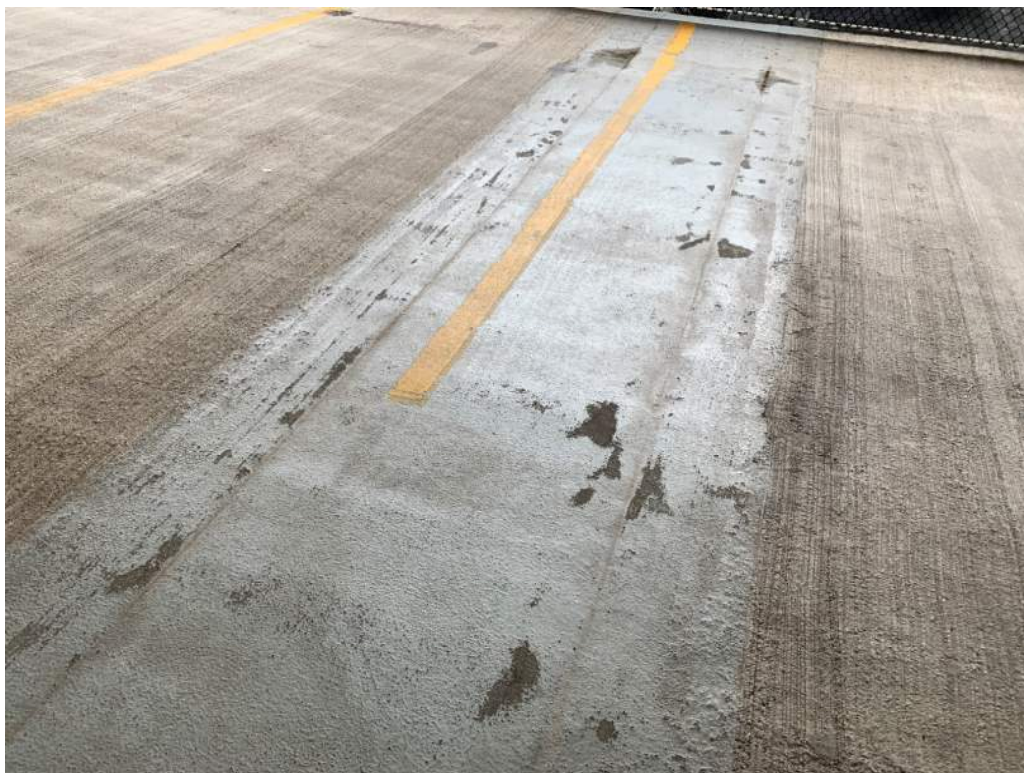
Photo 8 – Expansion Structure – Failed traffic coating over pour strip

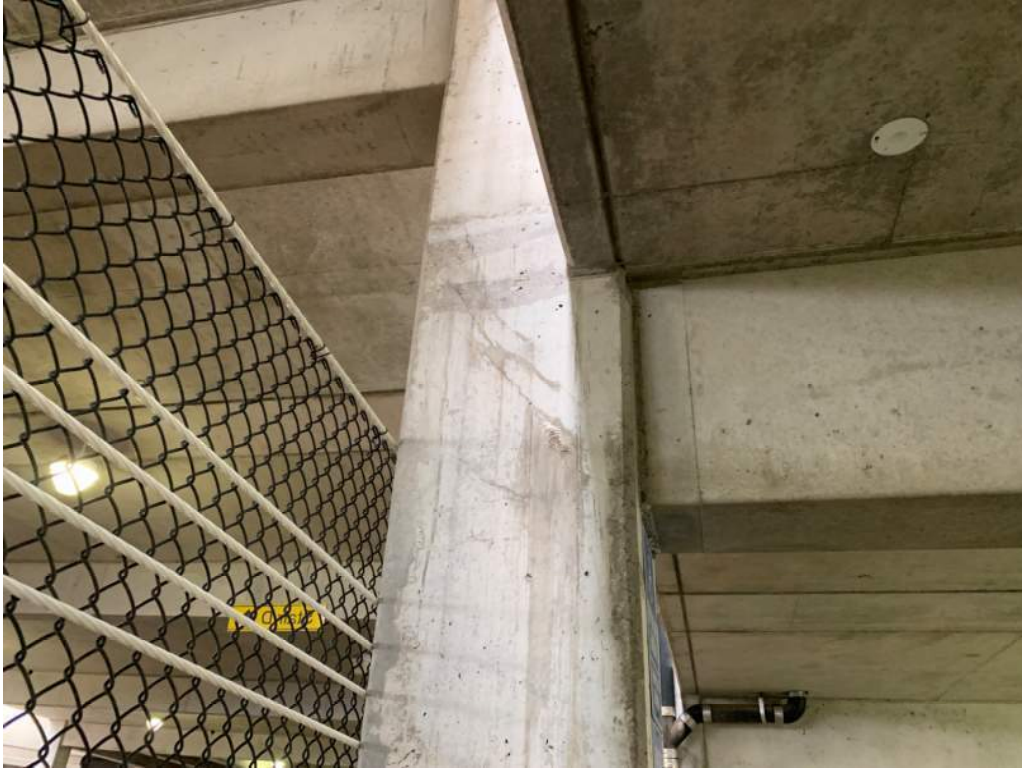
Photo 9 – Expansion Structure - Typical hairline column cracking at beam interface

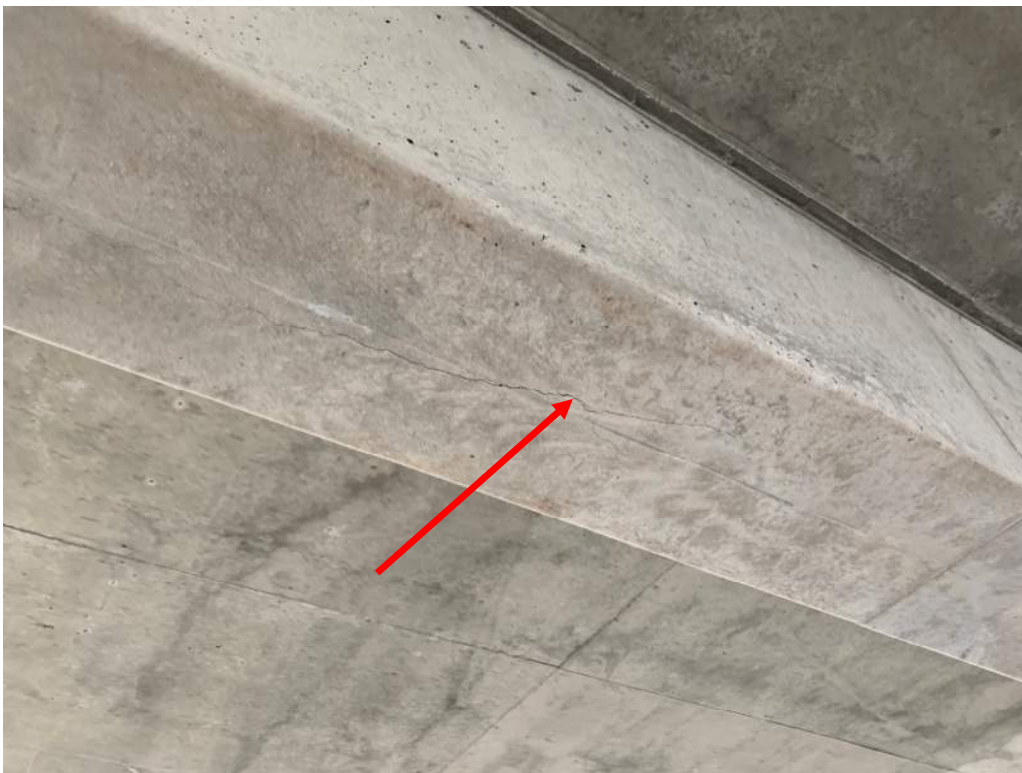
Photo 10 – Expansion Structure – Crack in bottom of beam supporting level 5 at grid C between grids 8 & 10 (Grid J similar)

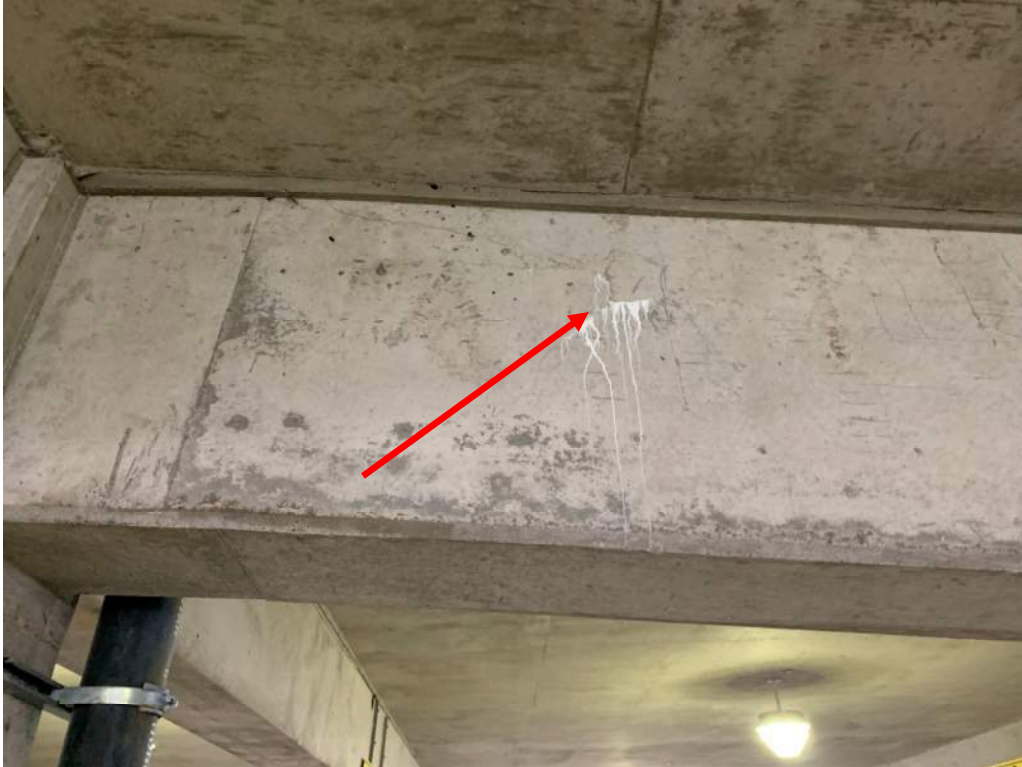
Photo 11 – Expansion Structure – Crack in beam web supporting level 5 on grid 8 between grids K & L

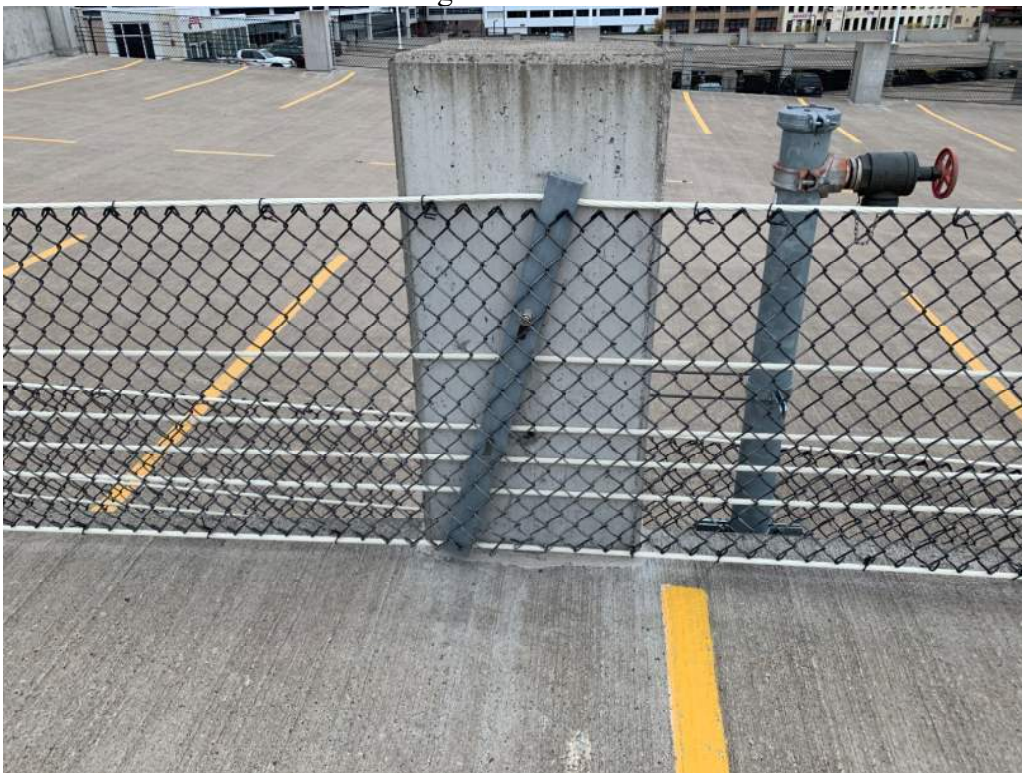
Photo 12 – Expansion Structure – Loose barrier cable bracket at column J/8
